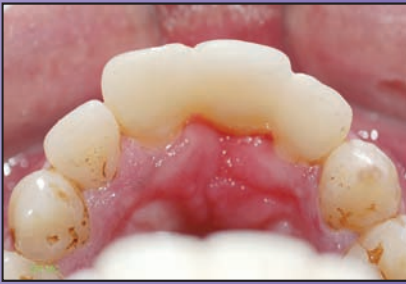
Fig 21 - Occlusal interferences should be checked and corrected. Excess bonding agent is removed and finishing and polishing procedures are carried out as usual.

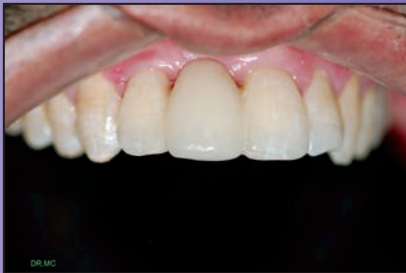
Fig 22 - Fiber-Splint Multi-Layer retained prosthesis on completion.

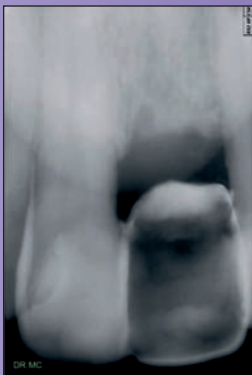
Fig 24 - Intra oral radiograph upon completion.

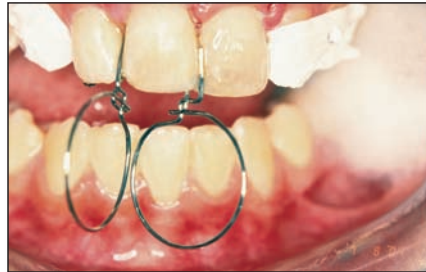
This figure shows the use of Polydentia's Fiber-Splint application clips
