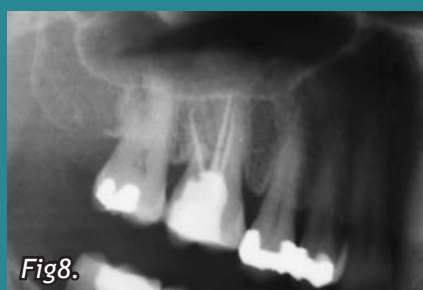
- Fig. 7: Follow up x-ray after 24 months: demonstrates the Ankylos TissueCare Concept that features bone over the implant shoulder*
- Fig. 8: Radiograph of tooth 16 shows the preparation of the furcation area*
- Fig. 9: Radiograph immediate post-op with vertical sinus lift*
- Fig. 10: Healthy gingiva three months after placement and ready for final impression*
- Fig. 11: Final crown 15 months post-op: note the excellent emergence profile*
- Fig. 12: Follow-up x-ray after 15 months: note the remodeling of the bone due to Ankylos TissueCare Concept*
- Fig. 13: Furcation bone after atraumatic extraction of the roots. Apical pathology still present*
- Fig. 14: Bone condensers to expand the furcation bone*

Wide diameter implants are generally placed in molar sites to compensate for the screw-retained connection. The wider diameter reduces the micro-motion and hence reduces the risk of screw loosening and possible implant fracture. The Ankylos system does not have this problem. The tapered connection and the TissueCare Concept (Fig. 7, 12, and 20) are capable of
